Incident Analysis Report: B696 MOVER Event, August 19, 2004

Report Serial Number: 0514

November 11, 2004, Rev. 1

Lawrence
Livermore
National
Laboratory

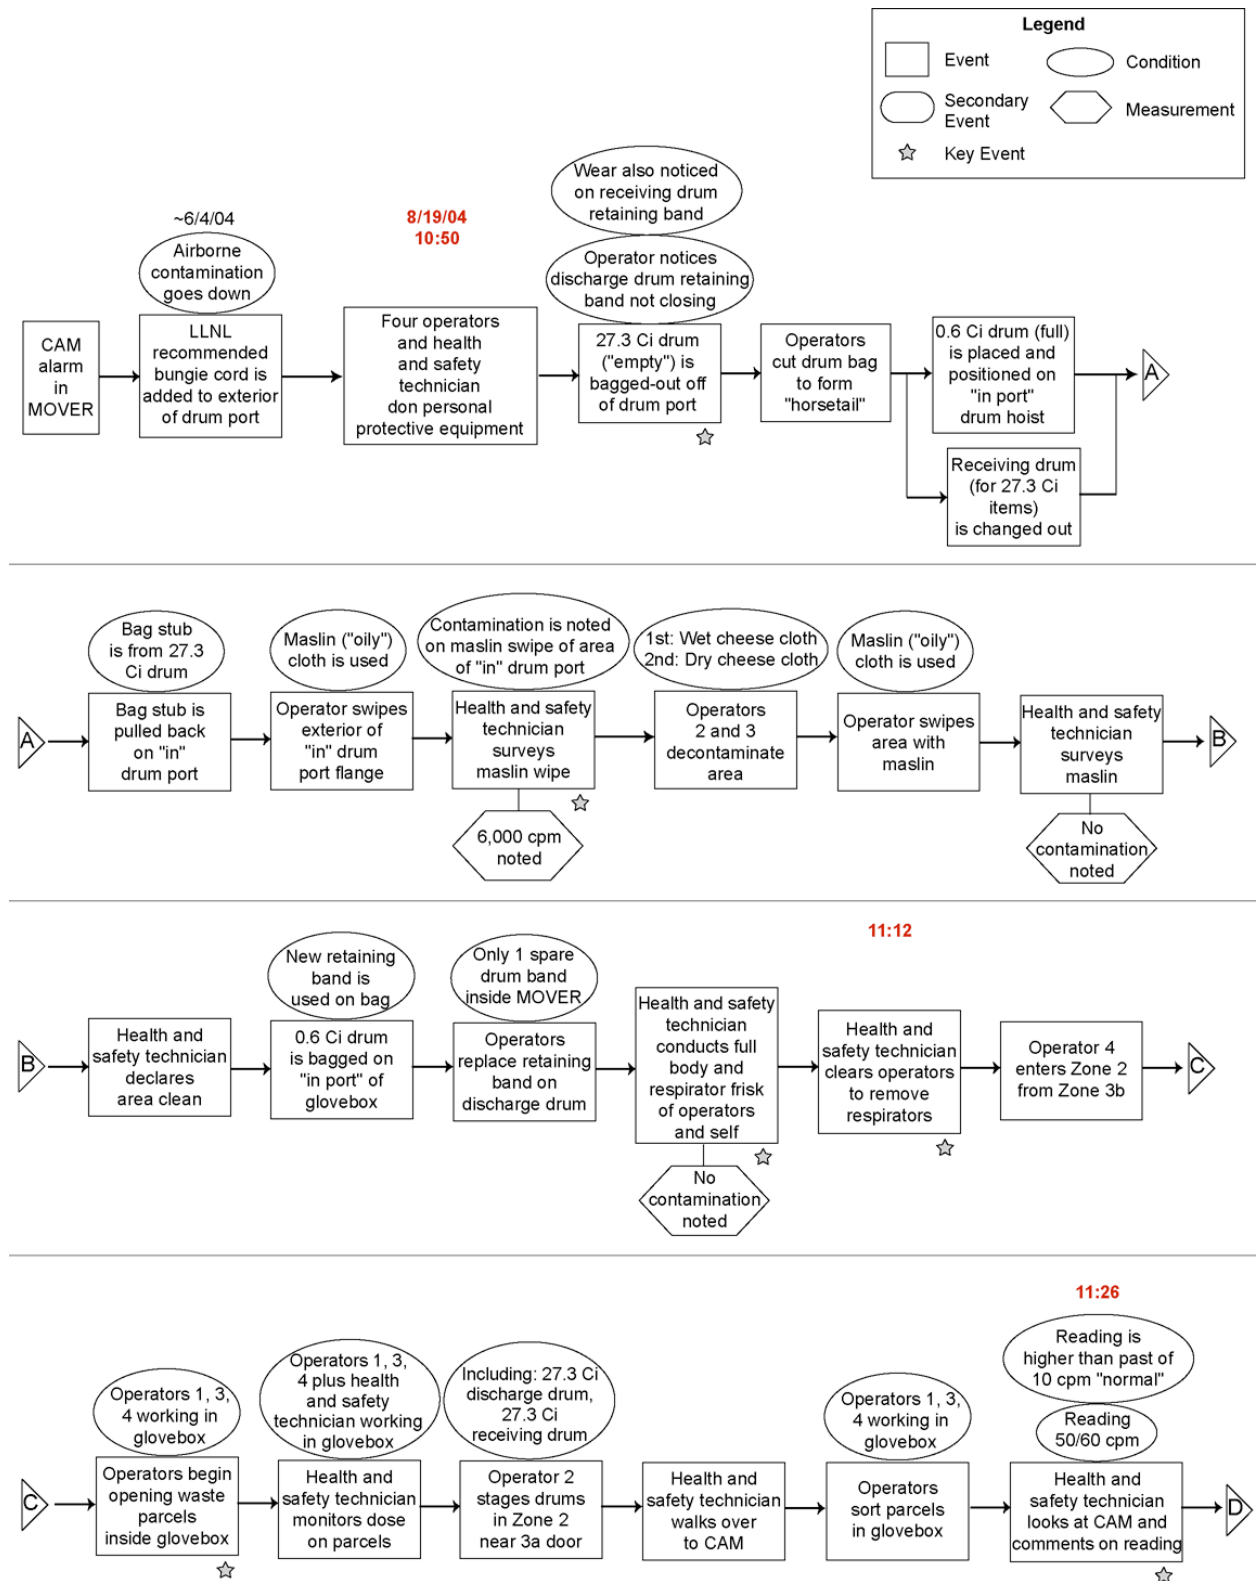
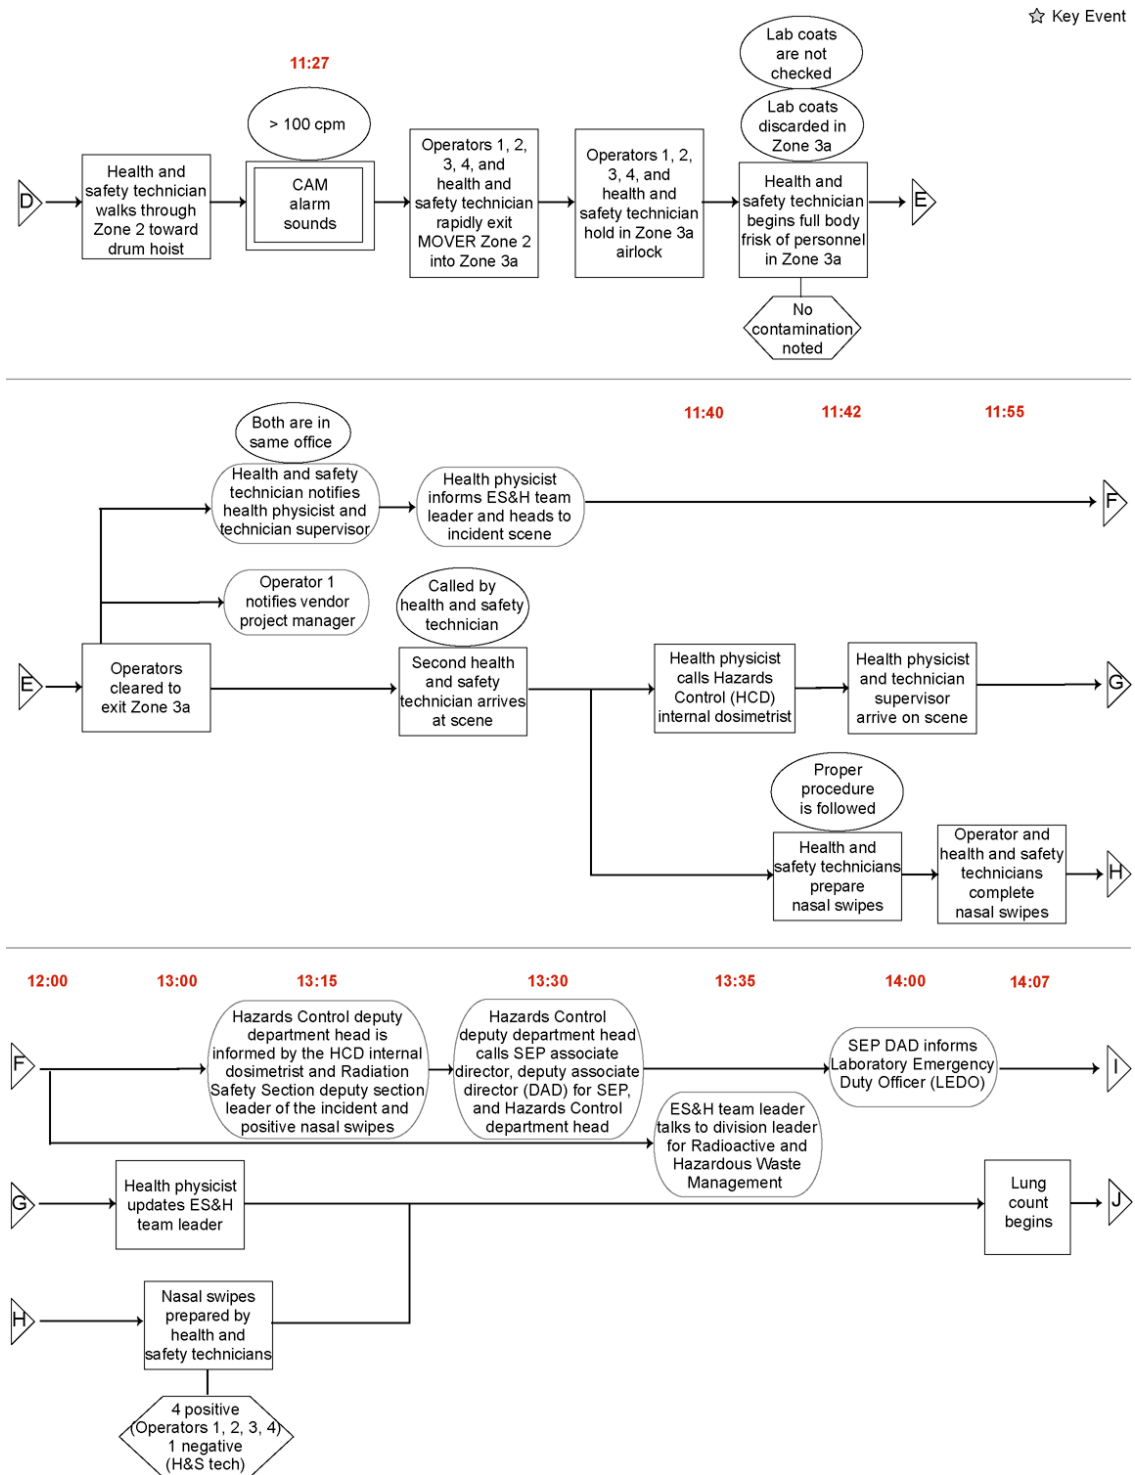
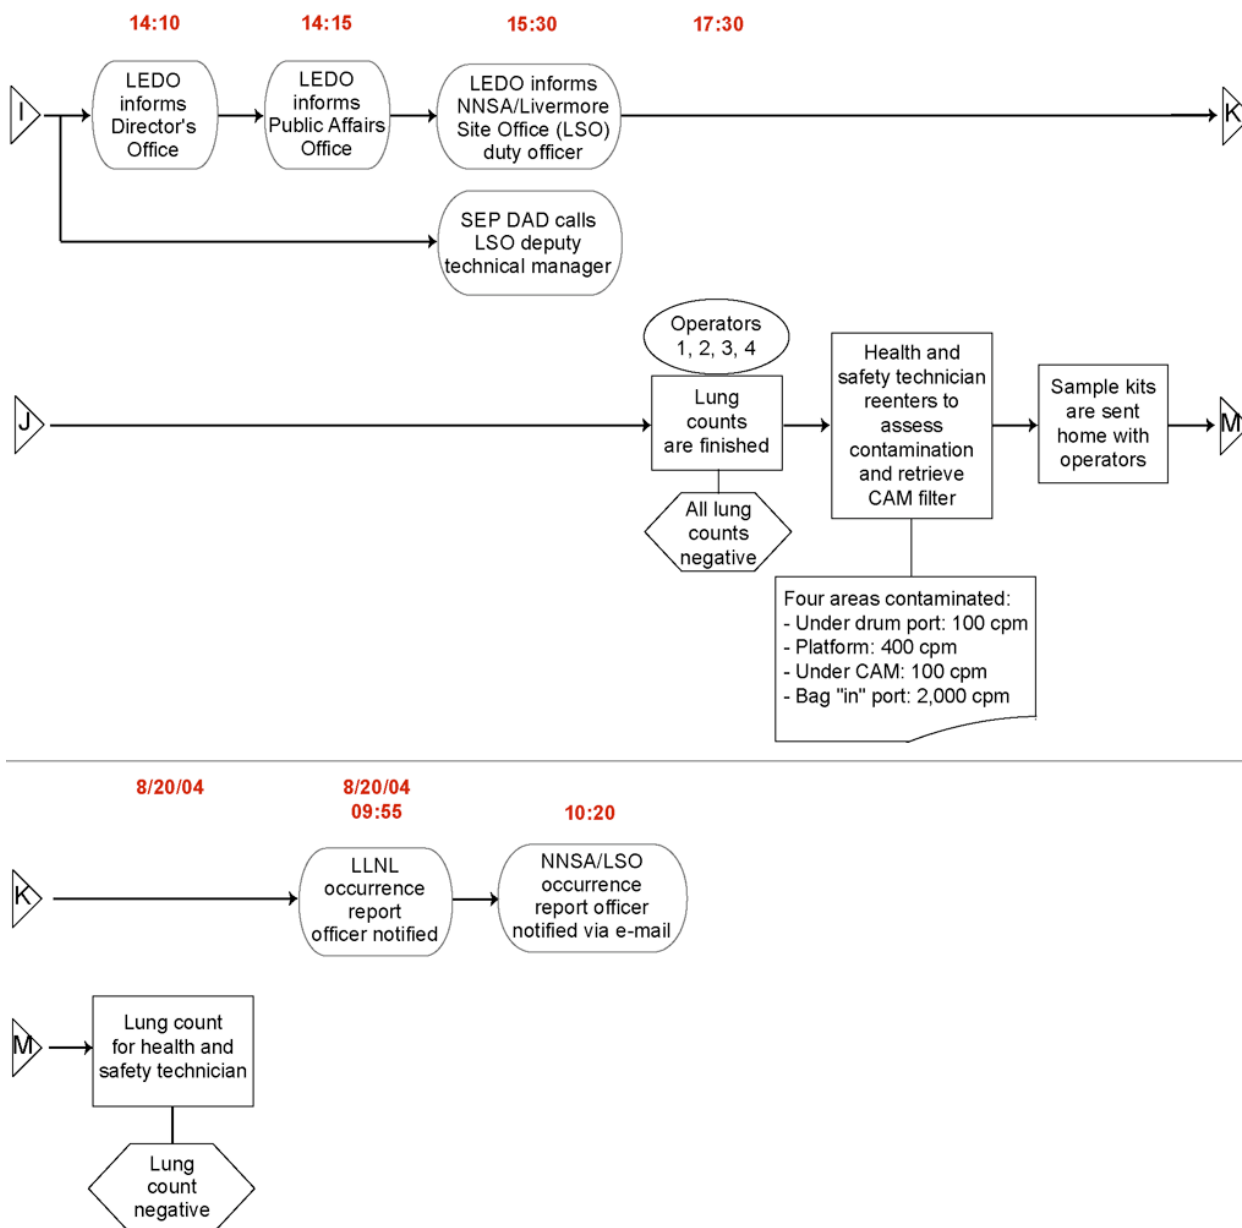
Figure 4. Event timeline.
NOTE: All indicated times are approximations.

Figure 4 shows the MOVER event timeline in detail. Refer to this figure for an overview of the sequence of events. At approximately 1055 hrs on August 19, 2004, three qualified MOVER operators and one H&ST donned respirators and personal protective equipment (PPE) and began work in the MOVER, Zone 2. The operators started the bag-out of a 27.3-PE Ci drum in accordance with CCP Procedure CCP-TP-042 and LLNL IWS 11359. Work was monitored by the H&ST, who is a certified Radiological Control Technician. During the bag-out process, the operators noticed that the metal retaining band that surrounded the bag over the discharge (“in”) drum port on the glovebox was not closing as tightly as normal. They also checked the band on the receiving drum port and noted wear on it. The operators continued with bag-out of the 27.3-PE Ci drum by moving it out of the drum port, with the bag still attached to the port. They proceeded to crimp, tape, and cut the bag to form “horsetails” of the newly separated bag segments. They also bagged out the drum located below the glovebox that received the checked contents from the 27.3-PE Ci discharge drum using the same procedural steps.

Post-event communication and notifications through the SEP and LLNL management chain were made as indicated in the Event Timeline (Figure 4). The notified personnel included three qualified LEDOs (the Deputy Department Head for HCD, Deputy Associate Director for SEP, and the on-duty LEDO). Although some judgment is necessary in making determinations as to

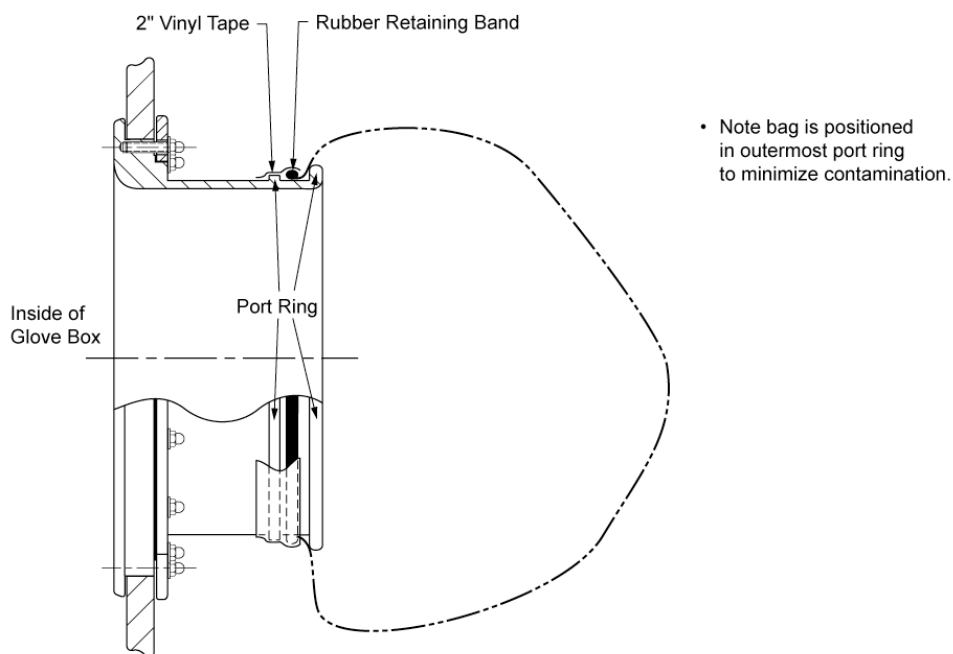
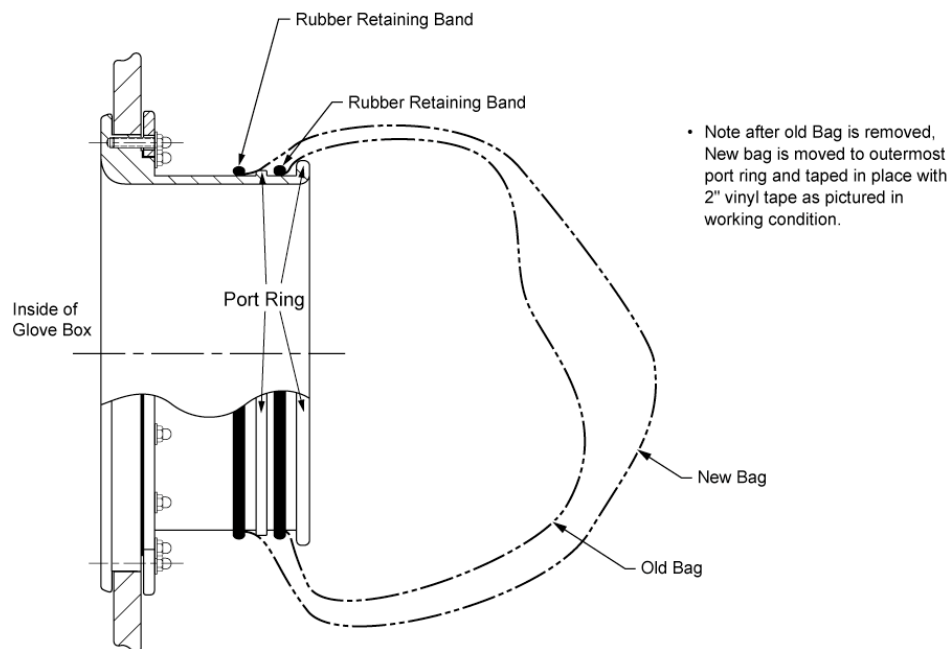
Figure 6. MOVER working configuration (top) and bag-change configuration (bottom).

During the bag-in process of the 0.6-PE Ci (or “full”) drum, and in accordance with CCP procedures, the operators pulled back the stub of the bag (from the 27.3-PE Ci drum) on the “in” drum port (see Figure 6, later in this report, for details on the MOVER bag configuration). This action exposed an area of the exterior surface so that the bag of the 0.6-PE Ci drum could be placed over the sub of the 27.3-PE Ci drum bag and secured to the drum port. Because the newly exposed surface was within the contamination envelope, it was known to be contaminated by the operators. After pulling back the stub, the operators checked the exposed exterior area by wiping it with an oily cloth (Maslin) and then having the H&ST survey the cloth. The H&ST used a Blue Alpha survey meter and measured 6,000 cpm, approximately 12,000 dpm/100 cm², on the Maslin swipe. The operators then decontaminated the area by first wiping it fully with wet cheese cloth and then dry cheese cloth. The area was swiped again with a Maslin cloth by the operators. The H&ST did not detect any contamination and declared the area to be clean.

The IA Committee evaluated the bag ports used on the MOVER glovebox (Figure 6) and compared them to the installation and design of similar bag ports at the LLNL Plutonium Facility (Figure 7), which is located in Building 332. The two types of bag ports are similar in design. However, the MOVER bag port is considerably larger to accommodate a 55-gal drum, whereas Plutonium Facility ports have a diameter of typically ~20 in. The larger size would not, in itself, have an affect on maintaining confinement of radioactive material.

Techniques used in the MOVER to secure the drum bag to bag port, as well as bag-changing techniques, are considerably different from the techniques used at the LLNL Plutonium Facility. The techniques used by CCP provided an opportunity for contamination on the bag port when changing a drum bag. Figures 6 and 7 compare the techniques used at the MOVER to those used at the LLNL Plutonium Facility.
